Manhole Inspection Summary

Manhole # S33S__013MH

Insp Date: **8/15/08 2:53 PM**

Location Address: **188 w ostend st**

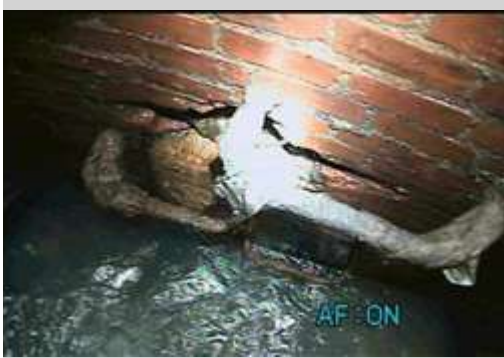
Defect 2

☒ **Evidence Of Surcharge**

Depth: **5.5** (ft.) ☐ Active Surcharge Present

evidence of surcharge

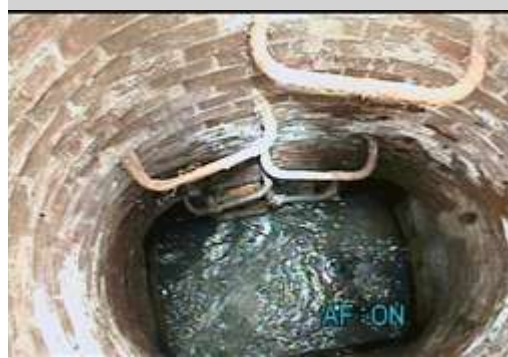
Defect 1

Count: **7** Missing: **0** ☒ **Corroded**

steps

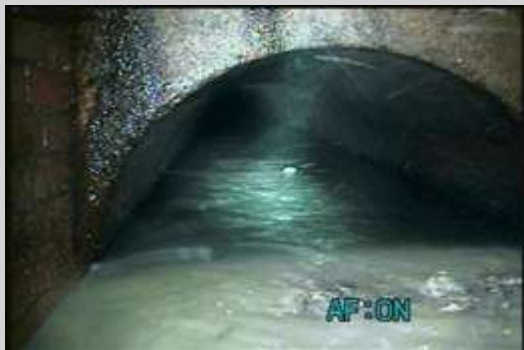
12 O'Clock Outflow

36 in. Circular Gravity Sewer
Pipe Out @ 12 O'Clock

Pipe Material: **Concrete** ☐ Pipe Lined

Invert Depth: **13.50** (ft.) Flow Characteristics: **Fast**

Deposits: ☒ None ☐ Mud ☐ Sludge ☐ Debris ☐ Grease

Infiltration: **None** Pipe Seal Cond: **Unknown**

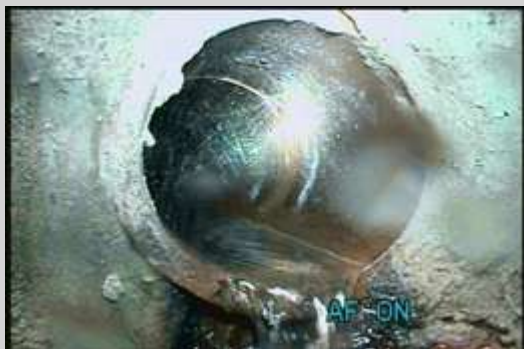
5 O'Clock Inflow

8 in. Circular Gravity Sewer
Pipe In @ 5 O'Clock

Pipe Material: **Clay** ☐ Pipe Lined

Invert Depth: **5.10** (ft.) Flow Characteristics: **Fast**

Deposits: ☒ None ☐ Mud ☐ Sludge ☐ Debris ☐ Grease

Infiltration: **None** Pipe Seal Cond: **Unknown**

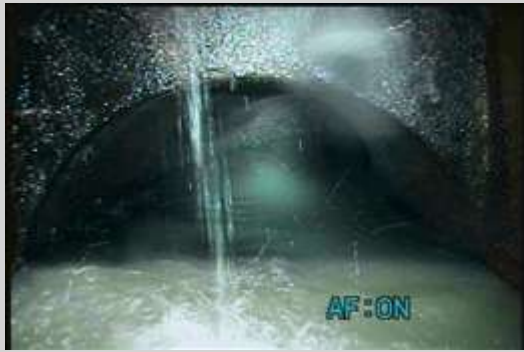
6 O'Clock Inflow

36 in. Circular Gravity Sewer

Pipe In @ 6 O'Clock

Pipe Material: **Concrete** ☐ Pipe Lined

Invert Depth: **13.00** (ft.) Flow Characteristics: **Fast**

Deposits: ☒ None ☐ Mud ☐ Sludge ☐ Debris ☐ Grease

Infiltration: **None** Pipe Seal Cond: **Unknown**

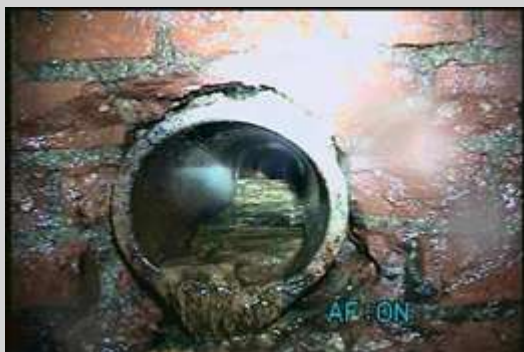
9 O'Clock Inflow

8 in. Circular Gravity Sewer

Pipe In @ 9 O'Clock

Pipe Material: **Clay** ☐ Pipe Lined

Invert Depth: **8.63** (ft.) Flow Characteristics: **Fast**

Deposits: ☒ None ☐ Mud ☐ Sludge ☐ Debris ☐ Grease

Infiltration: **None** Pipe Seal Cond: **Unknown**
